# Behind Closed Doors – What You Don’t Know About Your CVD Chamber

Sean Clancy, Ph.D., Robert Askin, HZO, Inc.  
Morrisville, NC, USA  
[sclancy@hzo.com](mailto:sclancy@hzo.com)

### **Case Study #1 – Intermittent and transient failures at FATP, or a series of unfortunate events**

#### **Case Study #2 – “Water is a contaminant, too, especially under vacuum”, or “evaporative cooling can be great, just not usually in your coating chamber”**

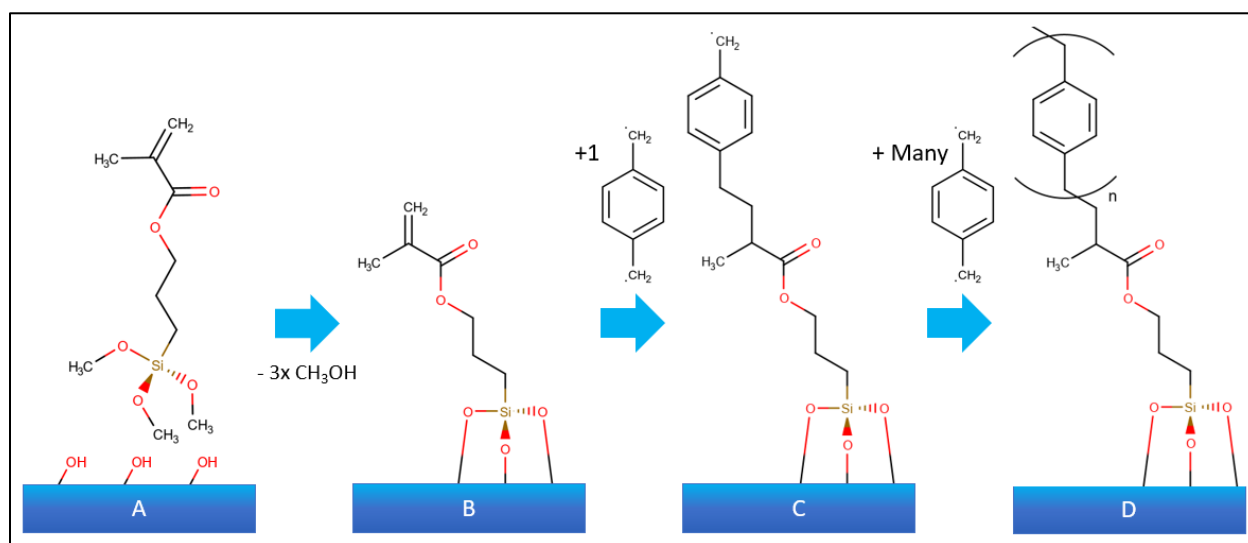
**Figure 2.** Overview of the adhesion promoter mechanism for chemically bonding parylene to a substrate.

Failure to power on phenomena was observed in user assemblies across multiple builds. These failures were isolated to something inherent in the CVD coating process, and the most likely candidate was the adhesion promoter (AP). The AP was the aforementioned Silane A-174, which has two functional ends, with the “feet” bonding to oxygenated sites on the substrate, and the “head” a methacrylate monomer that bonds to parylene monomers through a free radical reaction, as illustrated in Figure 2 below.

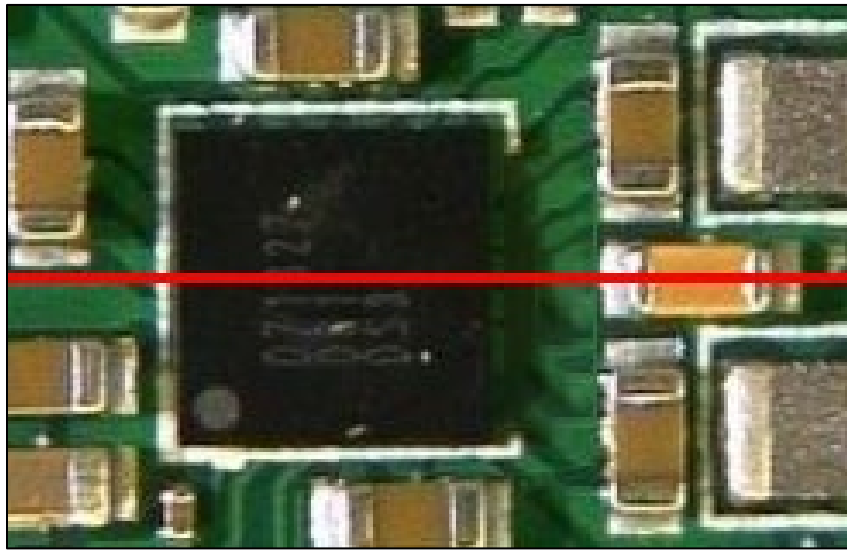
A coated assembly from the lot that experienced issues was cross-sectioned and evaluated for any issues of concern, especially around the PMIC component, and highlighted in Figure 3 below.

**Figure 3.** Location of the cross-section of the PMIC component on the PCBA.

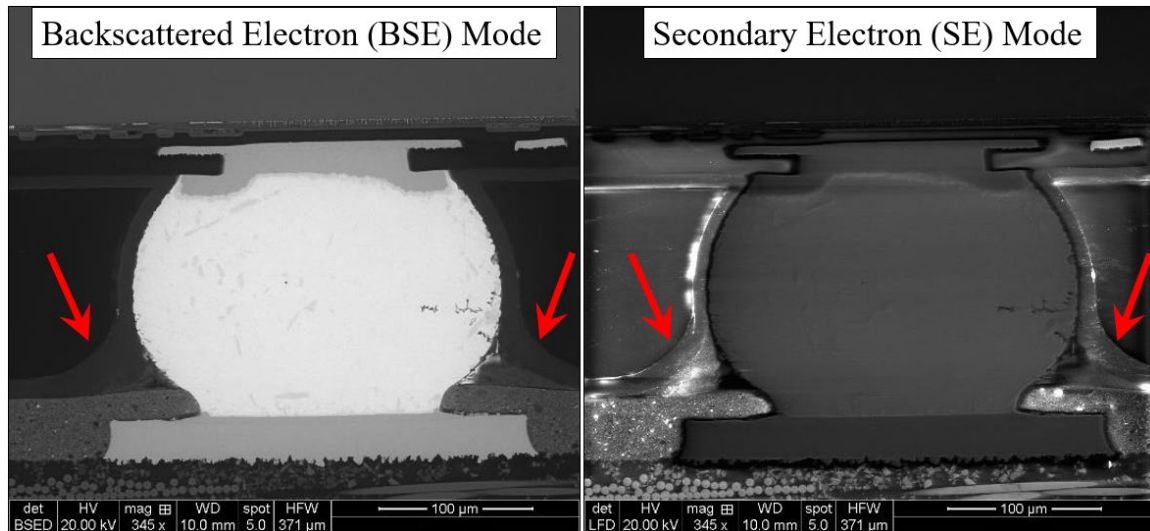
In Figure 4, the parylene coating appeared separated from the base of the BGA solder joints, which was likely due to the presence of flux residue that was coated over by the parylene and removed during the grinding, polishing, and requisite rinsing processes involved in cross-sectional sample preparation.

**Figure 4.** Scanning electron microscopy (SEM) images in backscattered-electron (BSE; left) and secondary electron (SE; right) modes, showing pockets at the base of the ball-grid array (BGA) solder joint, which likely covered from “no-clean” flux residues.

If desired, flux residue can be minimized by reducing the aperture size in the solder stencil, which will allow for a smaller amount of solder paste transferred to this component's location. A sufficient amount of solder paste and flux will still be needed to ensure good quality solder joints, as were observed on this assembly.

A smaller amount of flux residue would also be less likely to induce electrical shorts due to electrochemical migration (ECM) or dendritic growth, since less ionic residue would be present, whether it was solubilized in excess AP, moisture exposure, etc.

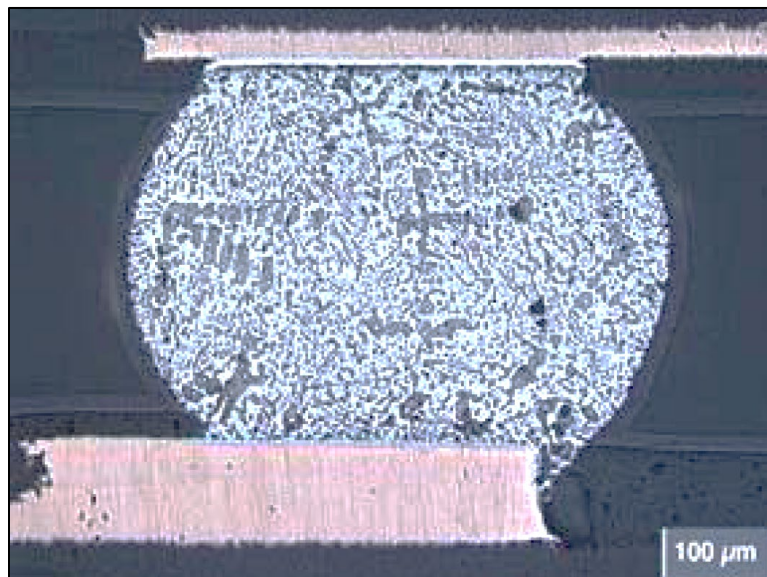
An example image of a cleaned PCBA that's been coated with parylene is shown in Figure 5 below, in which the coating completely conformed around the component body, solder joint, and the board, with no evidence of flux residues present.<sup>8</sup> Since flux residues weren't present, the coating didn't spread out and separate from the base of the joint.

**Figure 5.** Metallographic microscope image of parylene-coated BGA solder joint from a cleaned PCBA.

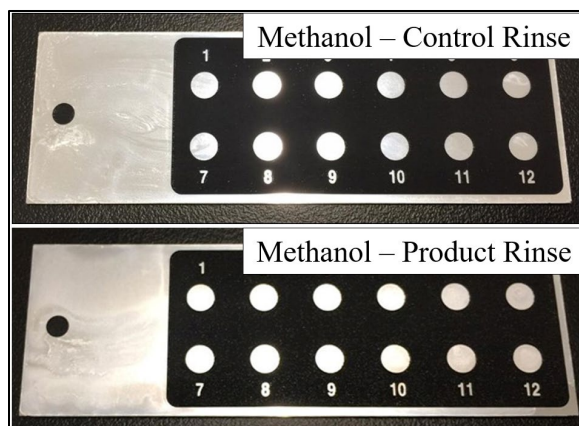
product-rinse, 3. Silane A-174 control, and 4. Silane A-174 product rinse were noted to have a meniscus of liquid and were left in a chemical hood with the sash pulled most of the way down to allow the solvents to evaporate. After 16 hours, the slides were examined and the methanol slides were dry and had visible residue, while the Silane A-174 slides still had a visible meniscus and were given additional time to dry. Figure 6 shows images of the methanol control and product rinse slides, where residue was observed on both. Note that it was unusual to see the residue on the methanol solvent control.

**Figure 6.** Residues were observed on both the methanol control and product rinse slides for Surface Organic Contaminant Detection Test. Relatively more residue was seen on the product rinse as compared to the control slide.

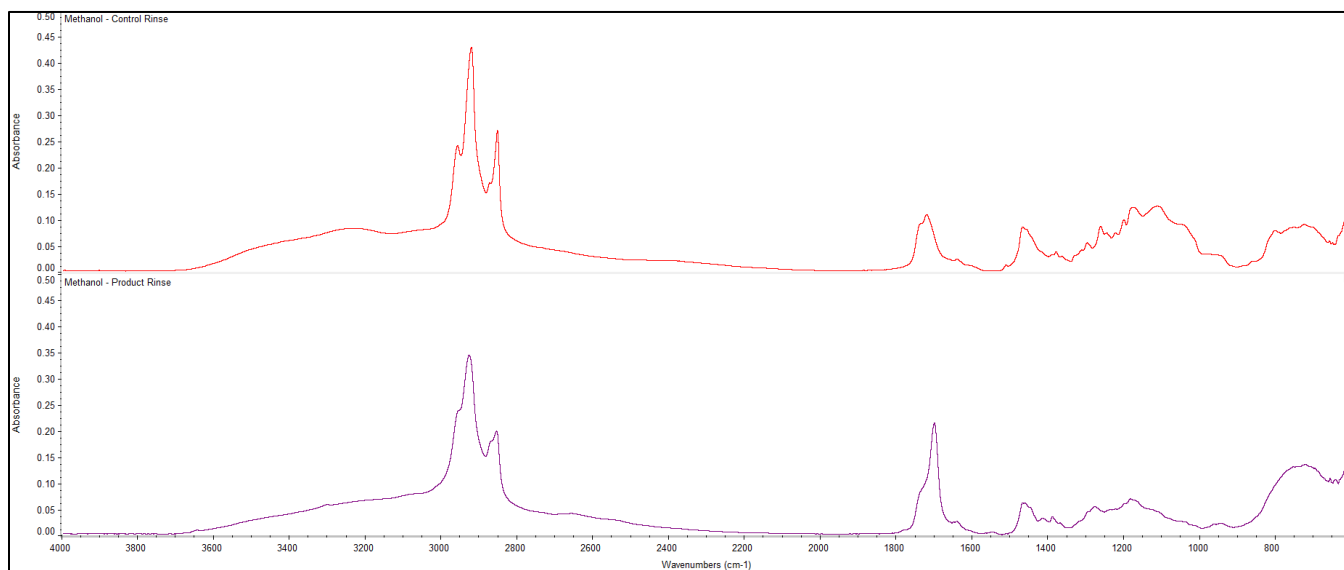
Fourier transform infrared (FTIR) spectroscopic analysis was performed with a Thermo Nicolet iS50 FTIR spectrometer equipped with a Smart iTR attenuated total reflectance (ATR) sampling accessory and germanium ATR crystal with 0.67  $\mu\text{m}$  penetration depth at  $1000\text{ cm}^{-1}$ . Thermo Fisher Scientific's "OMNIC" software was used for capturing and processing spectral data and "OMNIC Spectra" software was used for multicomponent spectral search with material databases. The FTIR spectra for the control and product rinse samples are shown in Figure 7.

**Figure 7.** FTIR spectra of the residue on the control rinse and product rinse slides.

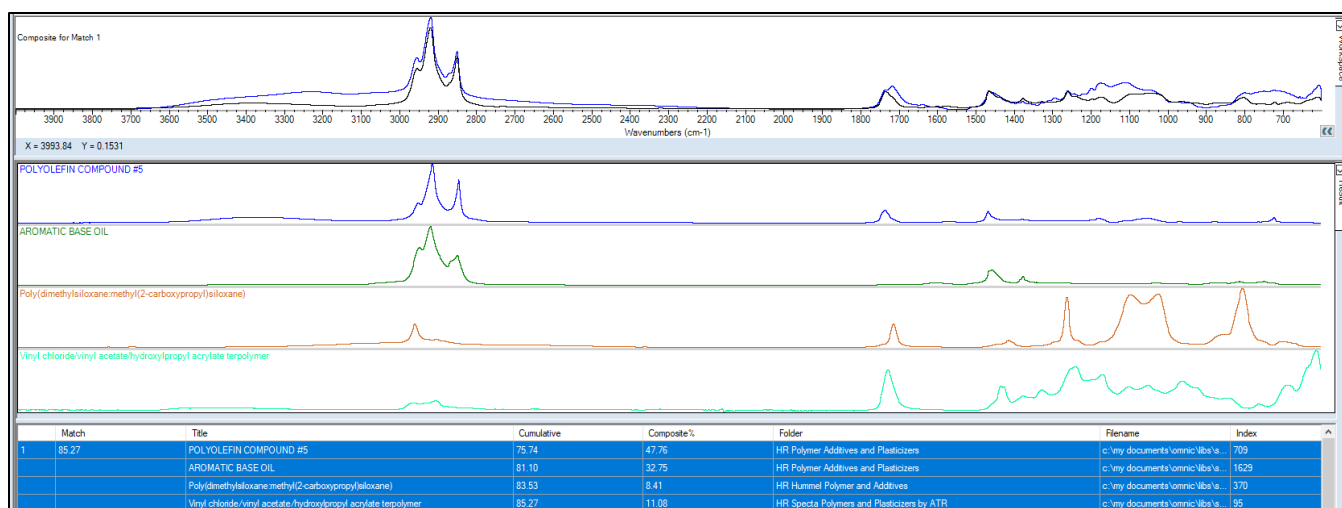
The FTIR analysis of the methanol control rinse sample showed peaks similar to oily, siloxane, and acrylic components (Figure 8), which were highly suggestive that the Silane A-174 contaminated the methanol slides through evaporation and re-deposition within the chemical hood. Future analyses would be repeated with a fresh solvent, a different product assembly, and away from the AP to mitigate any contribution from it.

**Figure 8.** FTIR spectrum multicomponent search results for the “Methanol – Control Rinse” sample.

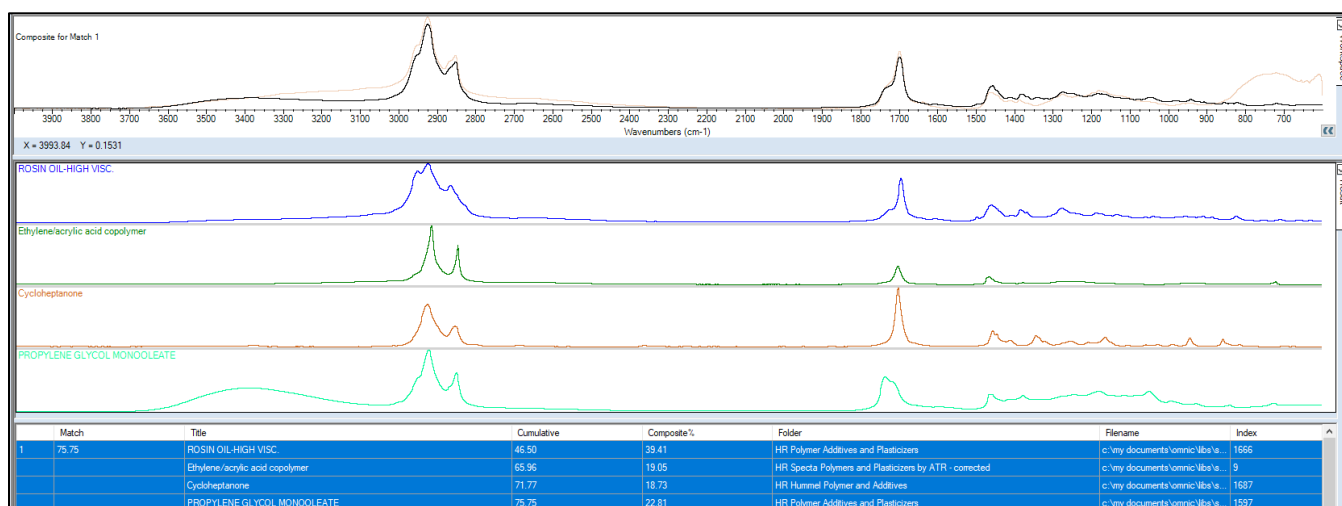
The FTIR analysis of the methanol product rinse sample showed the presence of a rosin material (Figure 9), which is a common ingredient in solder paste fluxes.

**Figure 9.** FTIR spectrum multicomponent search results for the “Methanol – Product Rinse” sample.

The user shared the safety data sheet (SDS) for the solder paste that was used, and the findings from the product rinse agreed with the listed composition of the flux in the solder paste, which is listed in Table 2. The last three rows are the flux in the solder paste. Upon researching the CAS numbers, both the rosin and resin components are rosin-based compounds. The activator was a collection of various length, medium-chain carboxylic acids, which along with the rosin and resin, serve as the flux.

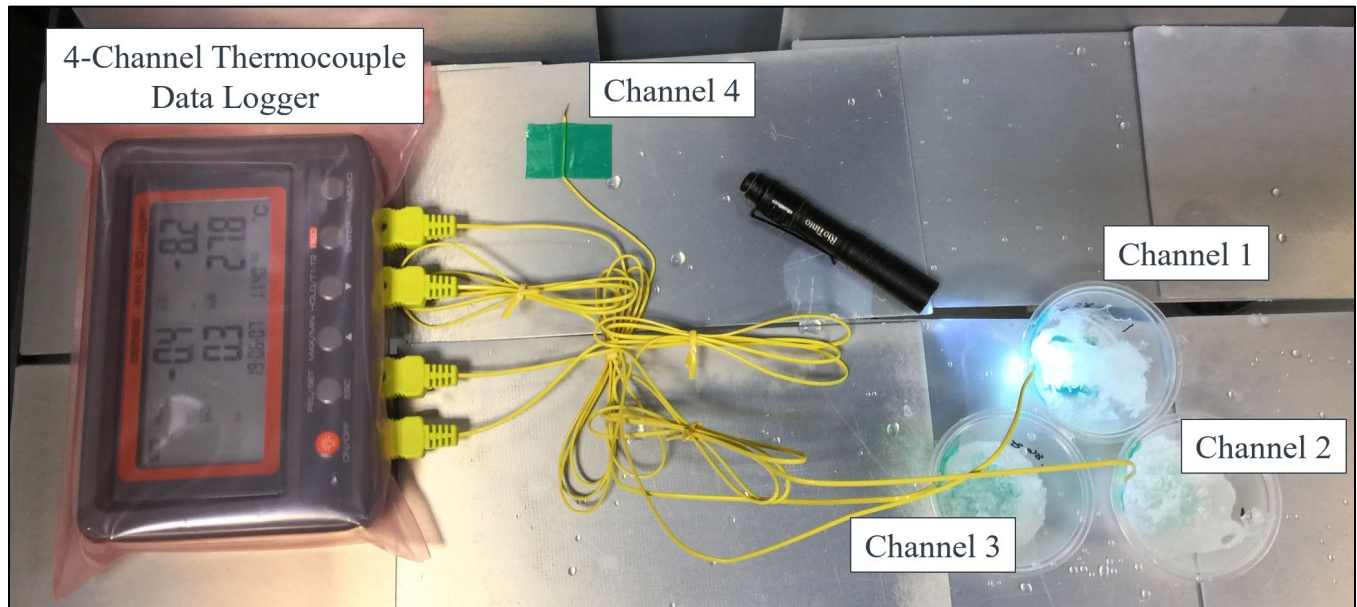
A set of experiments were performed to evaluate how long it would take for water to freeze during the CVD chamber pump down process, as well as incorporating pauses at varying pressure levels to evaluate the water removal process. An example setup is shown in Figure 10, where a 4-channel thermocouple data logger was placed to run in the chamber with 3 thermocouples placed in small cups of water and 1 thermocouple serving as a control.

**Figure 10.** Experiment setup with thermocouple data logger with three thermocouples (Channels 1 through 3) placed in small cups of water, one thermocouple as a control on Channel 4, and a small flashlight to serve as a light source for viewing through the chamber's viewport.

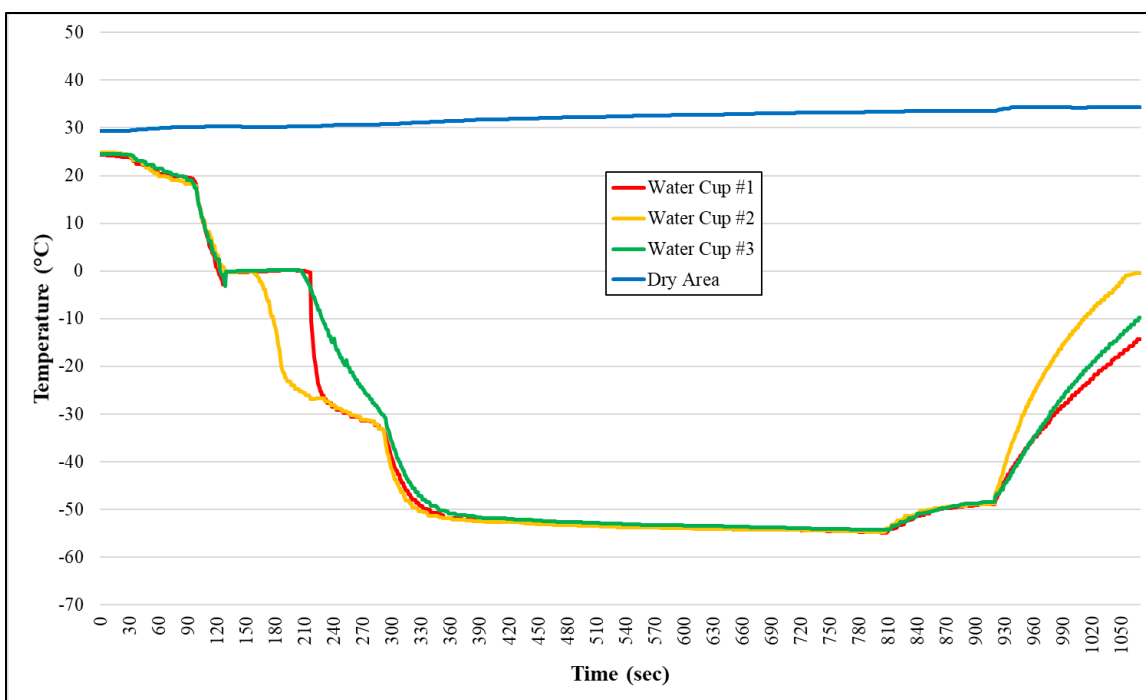
The thermocouple data were plotted as the time-series temperature data shown in Figure 11. The control thermocouple showed a slight increase in temperature over time, while the three thermocouples that were in the water experienced temperatures below -50 °C.

**Figure 11.** Time-series temperature for the three thermocouples placed in small cups of water and one serving as a control.

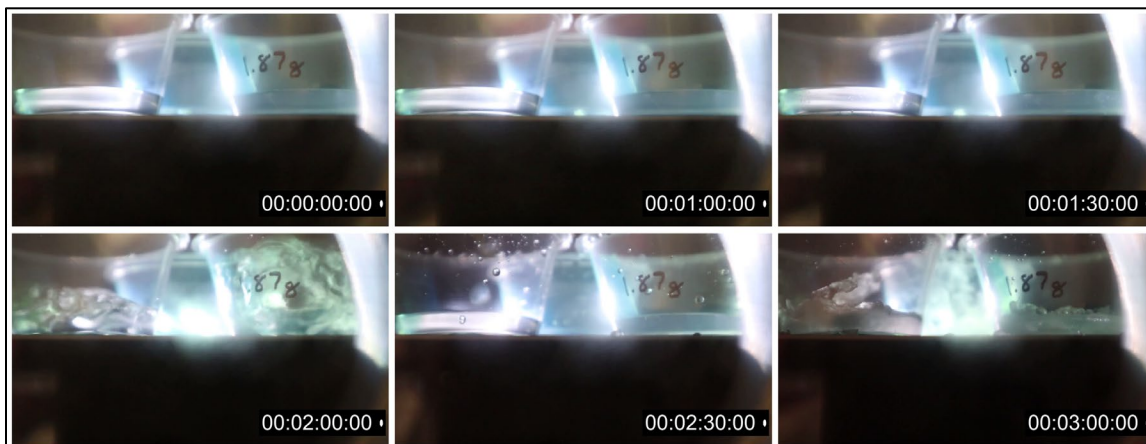
A camera was observing the process through the chamber's viewport and a video was captured for the process. Figure 12 shows a series of still frames with a time code starting when the system started to pump down from atmospheric pressure. By the 2 minute mark, the water was boiling vigorously, while by 3 minutes the water appeared frozen. The temperature continued to drop with no major visible differences observed.

**Figure 12.** A series of snapshots from the video that was captured through the parylene CVD chamber's viewport. Water boiled vigorously by the 2-minute mark and appeared frozen by 3 minutes.

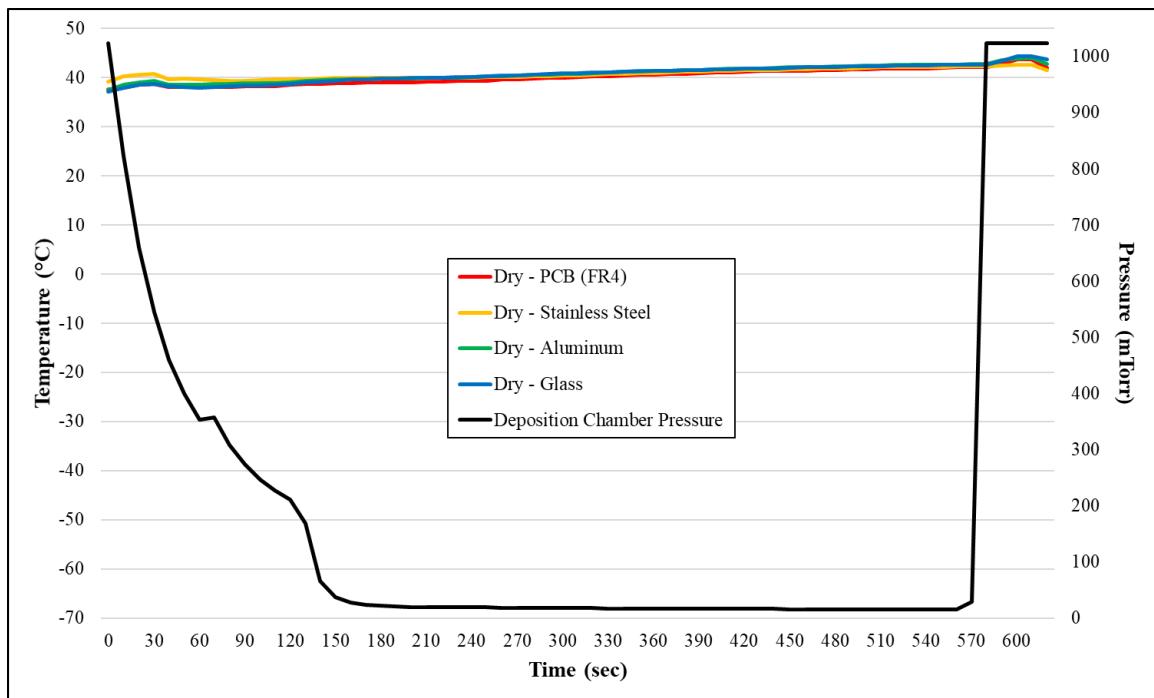
Additional experiments were performed with four different substrates: an FR4 PCB, a stainless steel panel, an aluminum panel, and a glass slide, with and without water present to evaluate the effects of the evaporative cooling. Figure 13 shows the dry samples with no appreciable difference, as was expected. Figure 14 shows the samples which had 5 mL of water placed on each substrate, with significant changes observed and temperatures again reaching below -50 °C. Representative pressure curves were included on each plot to show the changes in pressures achieved during this process.

**Figure 13.** Temperature vs time study of four different dry substrates during the chamber pump down process. No appreciable difference was observed for each material type: FR4 PCB, a stainless-steel panel, an aluminum panel, and a glass slide.

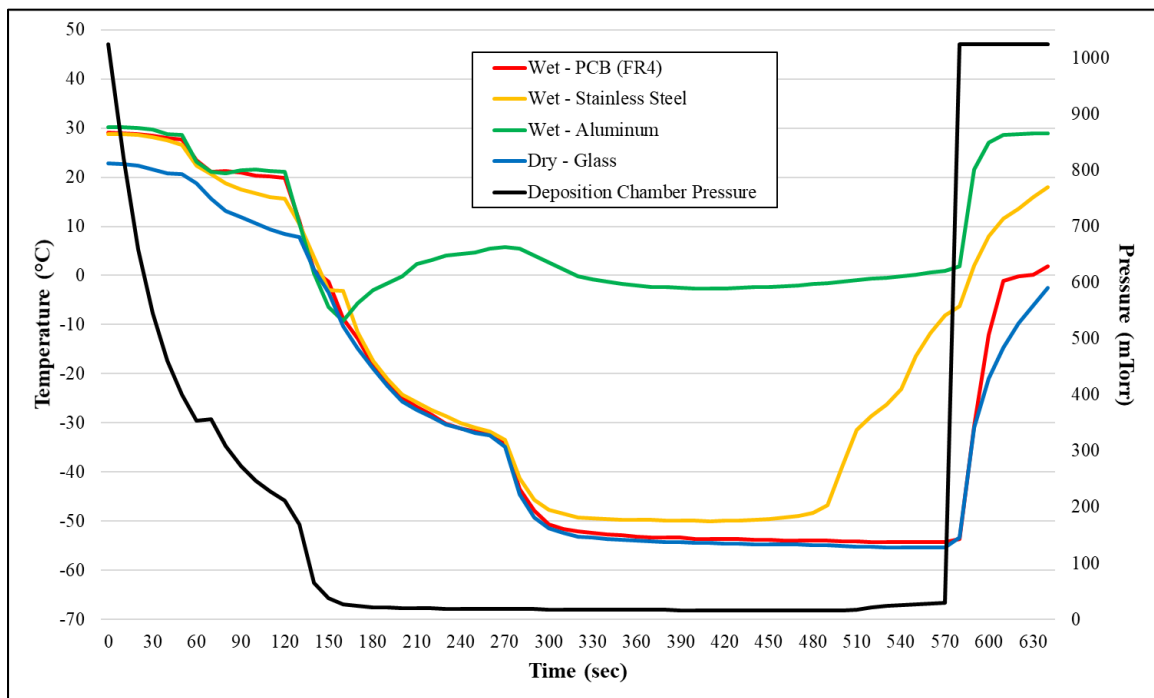
**Figure 14.** Temperature vs time study of four different wet substrates during the chamber pump down process. No appreciable difference was observed for each material type: FR4 PCB, a stainless-steel panel, an aluminum panel, and a glass slide. Note that the aluminum sample likely had ice break off of the thermocouple area, so the temperature didn't reach the lowest values.

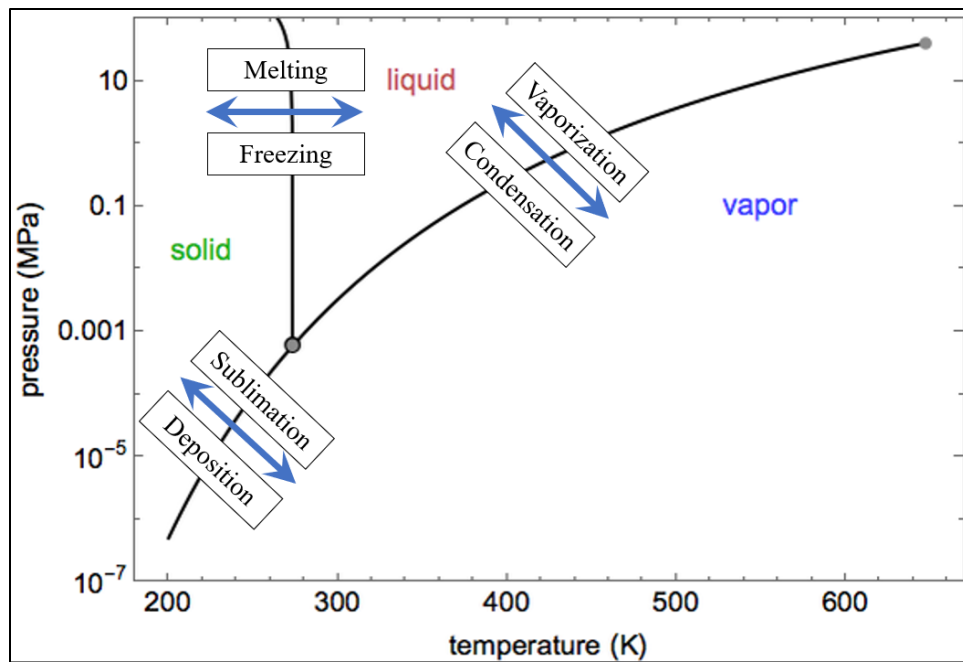
Once the water was frozen and still under vacuum, the ice then sublimates from a solid to a gas, enabling the temperature to remain low, and eventually freeze-drying the product. A phase diagram for water is shown in Figure 15,<sup>9</sup> with labels on each of the phase transitions.

**Figure 15.** Pressure-temperature phase diagram for water with each of the transitions labeled.

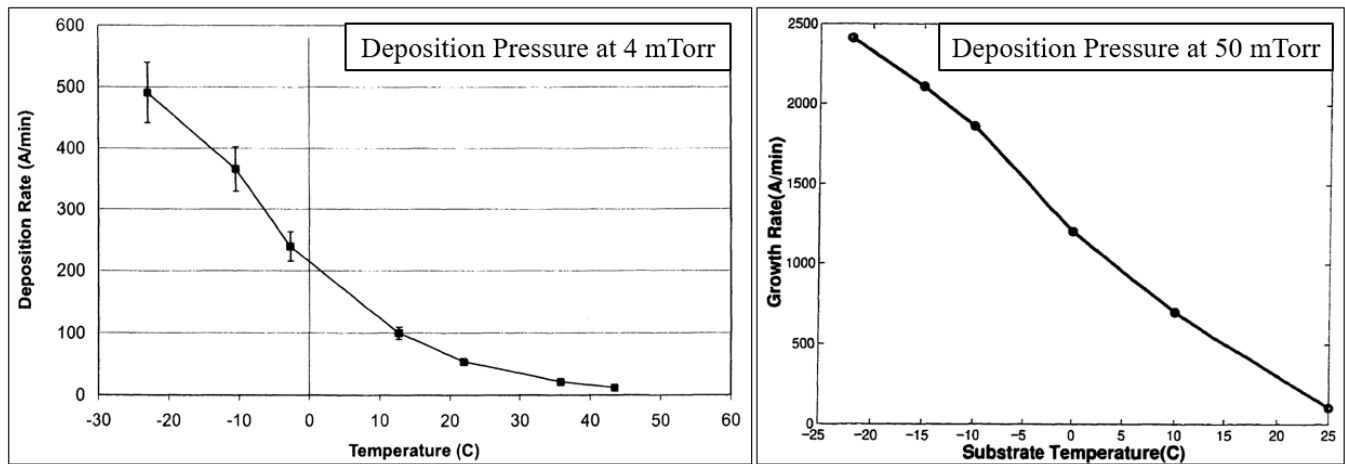
One of the properties of parylenes is that there's an increase in the deposition rate with the corresponding decrease in substrate temperature. Examples of this relationship are illustrated in Figure 16 at two different deposition pressure regimes.

**Figure 16.** Deposition rate vs temperature of parylene N for example deposition systems operating at 4.0 mTorr<sup>10</sup> and 50 mTorr<sup>11</sup> deposition chamber pressures.

It was concluded that the vacuum process, along with the environmental variations in relative humidity and water adsorption, led to significant evaporative cooling of substrates. Once these parts were cooled in a vacuum, they stayed cold due to lack of convection. Additionally, with rapid vacuum introduction on small loads and using a large vacuum pump, we observed frost or ice formation on the parts. This frost then sublimates slower than liquid would evaporate, reaching a much lower minimum temperature than ice at atmospheric pressure and increasing the likelihood that parts are cold at the start of deposition. As noted above, the polymerization of parylene N occurs more rapidly at lower substrate temperatures and would result in thicker coatings in colder regions.

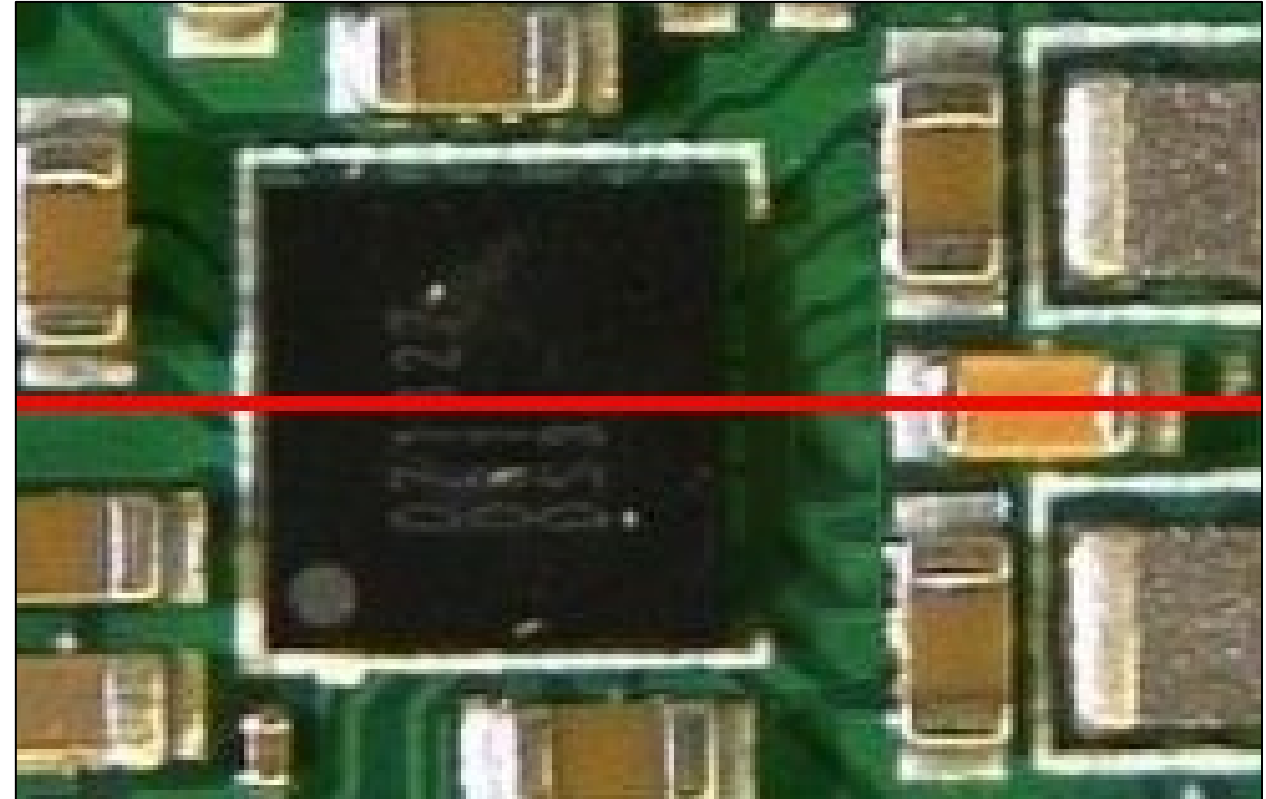
## CS#1 – Location of the Cross-Section

- Cross-sectioned coated PMIC with location noted with red line

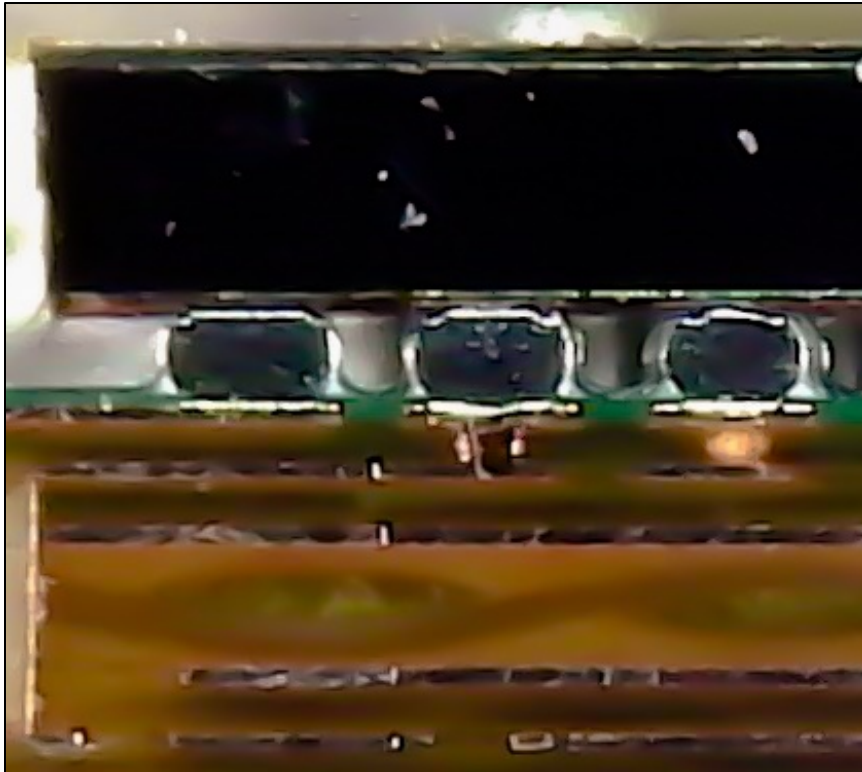
## CS#1 – PMIC Component Cross-Section – Optical Microscopy

- Parylene conforms to all surfaces
- Pockets were observed at the base of the BGA solder joints
- Pockets were most likely the result of “no-clean” flux residues

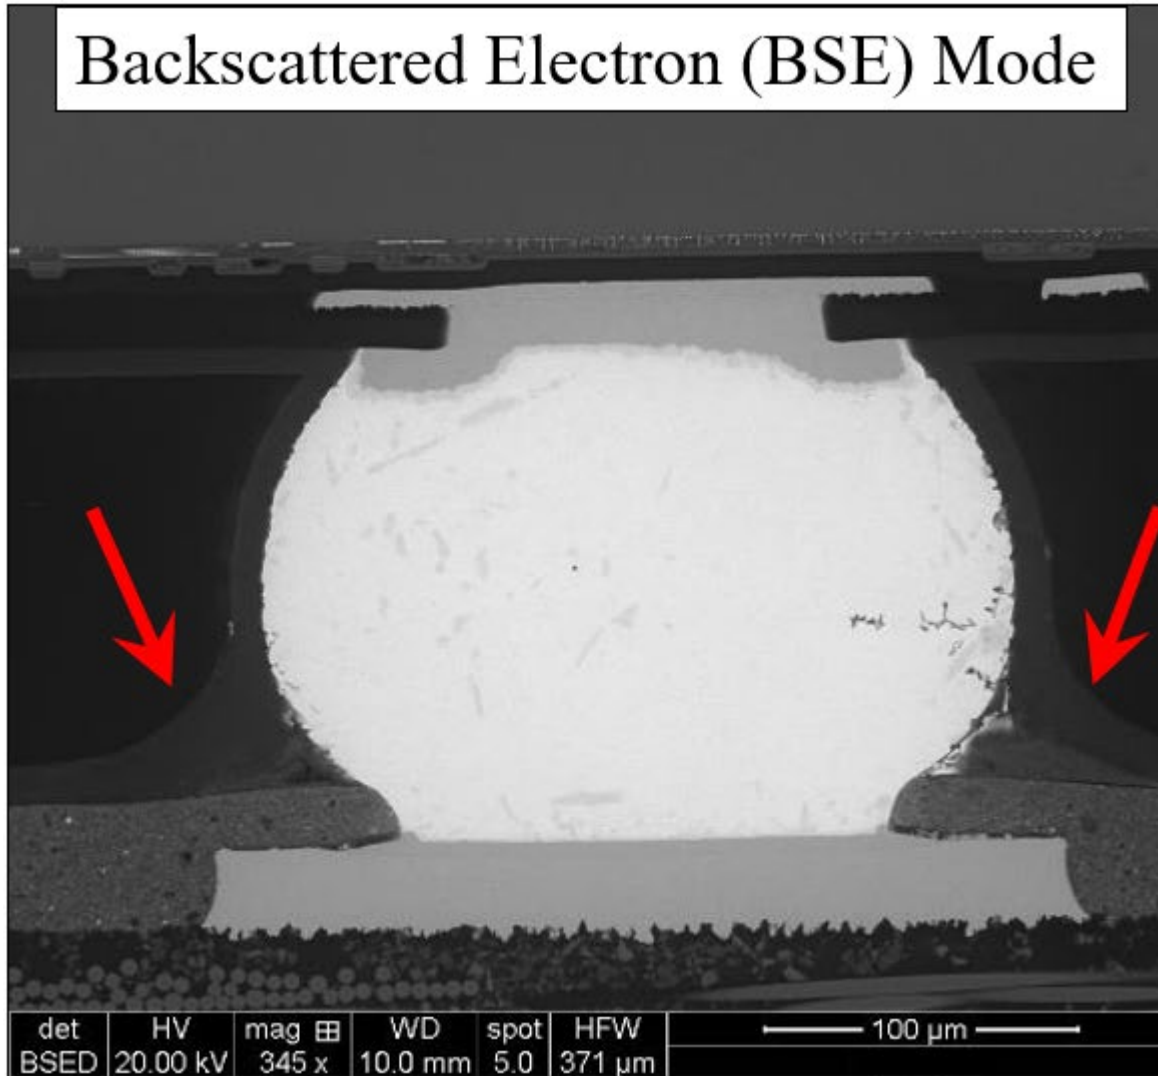
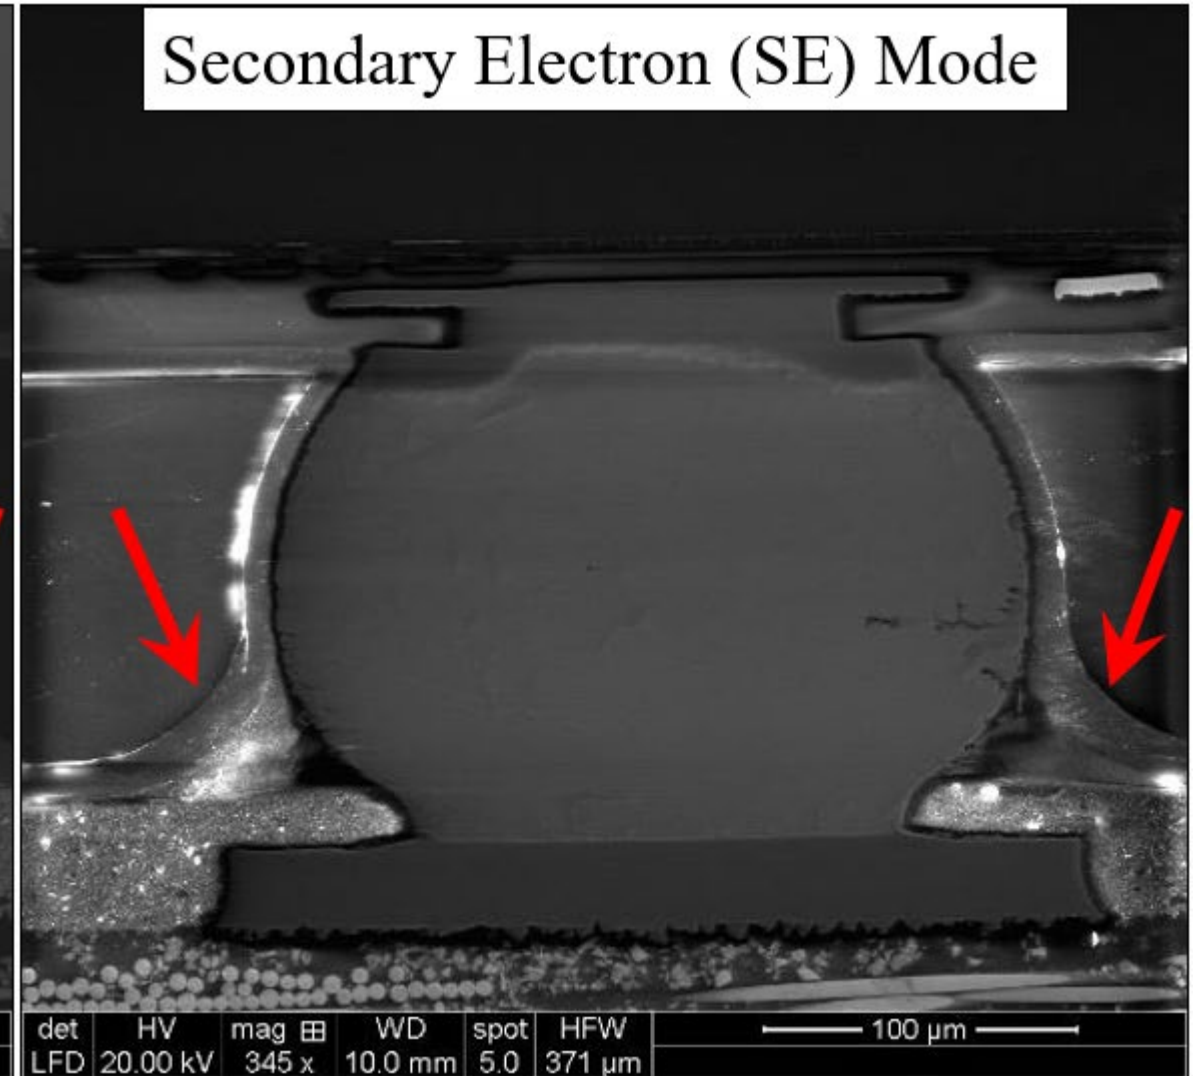
# CS#1 – PMIC Component Cross-Section – SEM Imaging

Backscattered Electron (BSE) Mode

Secondary Electron (SE) Mode

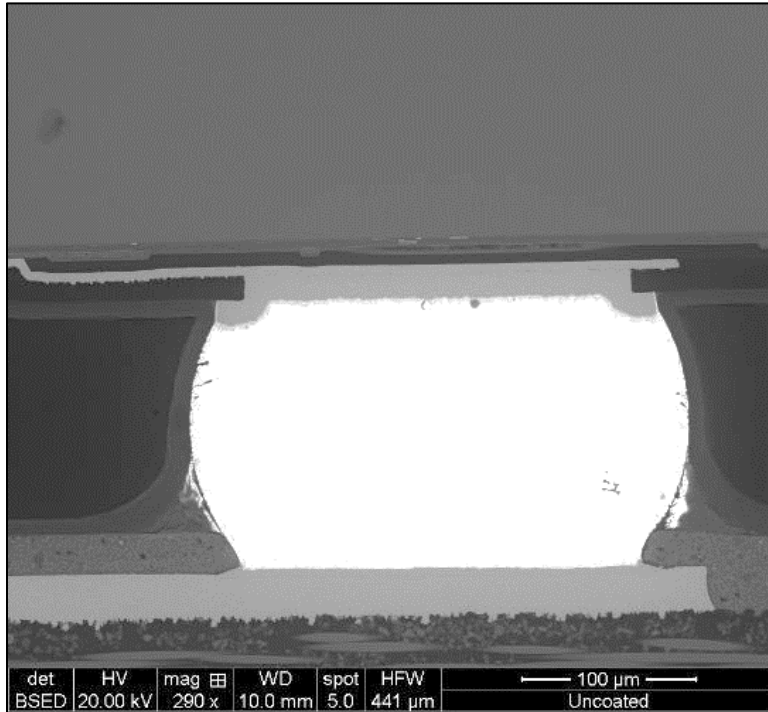
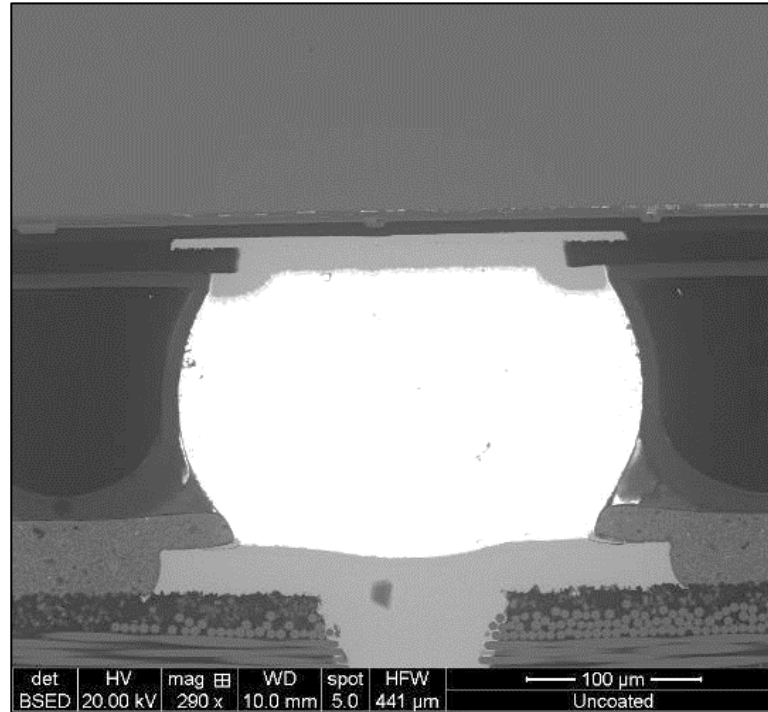
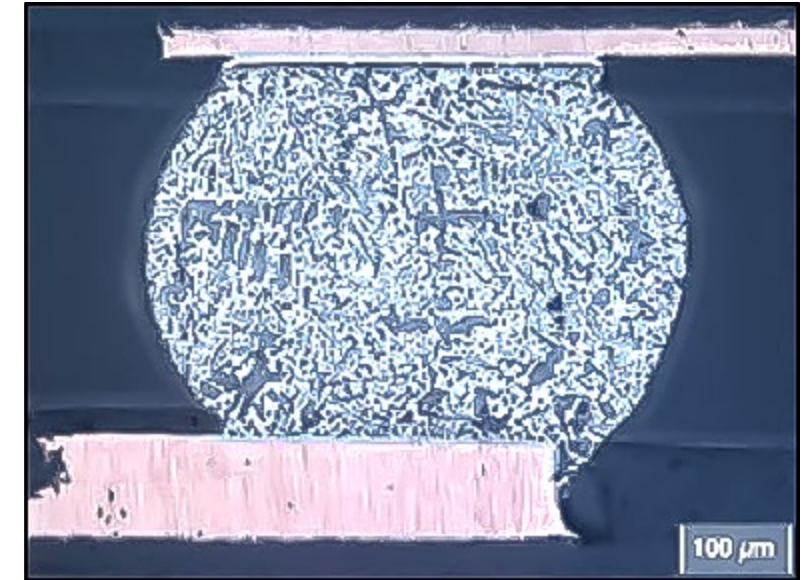
# CS#1 – Coating Conformality – “No-Clean” vs Clean

- Pockets at BGA solder joints on “no-clean” assembly

- No pockets on BGA solder joints on cleaned assembly
- Ref.: R. Wilcoxon, D. Hillman, D. Pauls, D. White, “The Impact of Improper Conformal Coating Processes on BGA Solder Joint Integrity”, *Proc. of SMTA International Conference*, **2015**, 870.

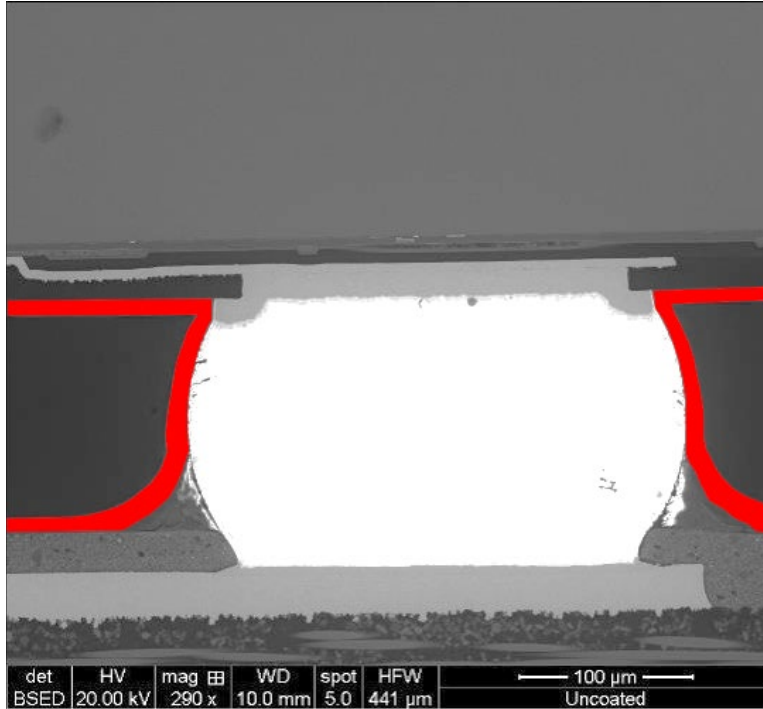
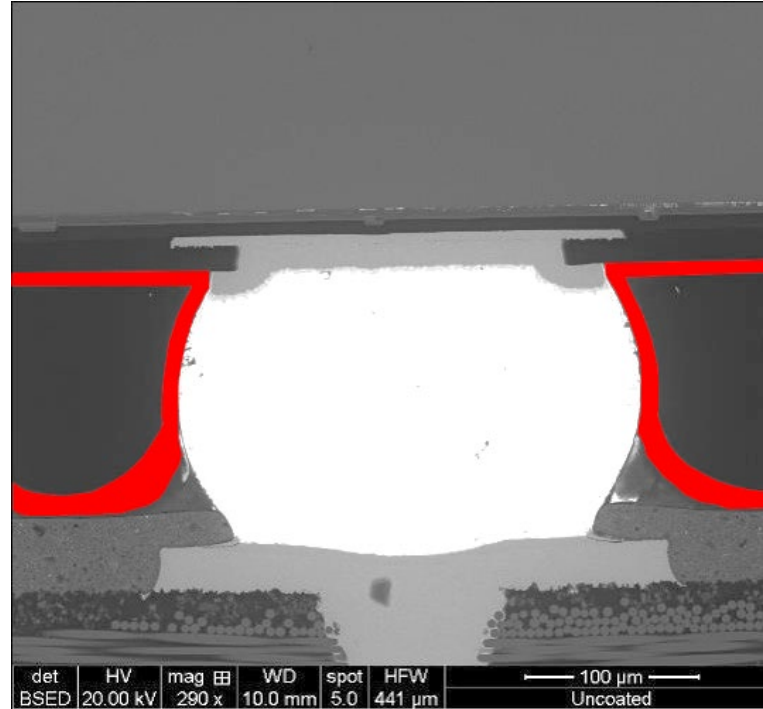
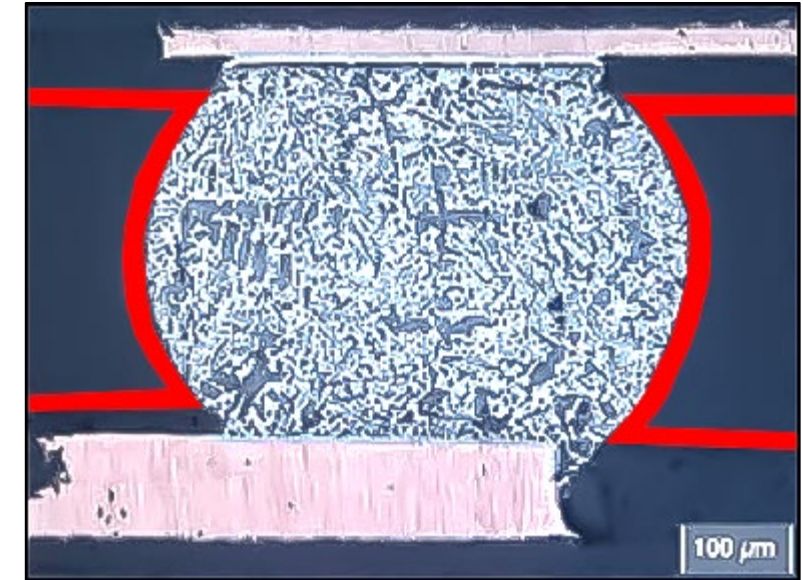
# CS#1 – Coating Conformality – “No-Clean” vs Clean

- Pockets at BGA solder joints on “no-clean” assembly

- No pockets on BGA solder joints on cleaned assembly
- Ref.: R. Wilcoxon, D. Hillman, D. Pauls, D. White, “The Impact of Improper Conformal Coating Processes on BGA Solder Joint Integrity”, *Proc. of SMTA International Conference*, **2015**, 870.

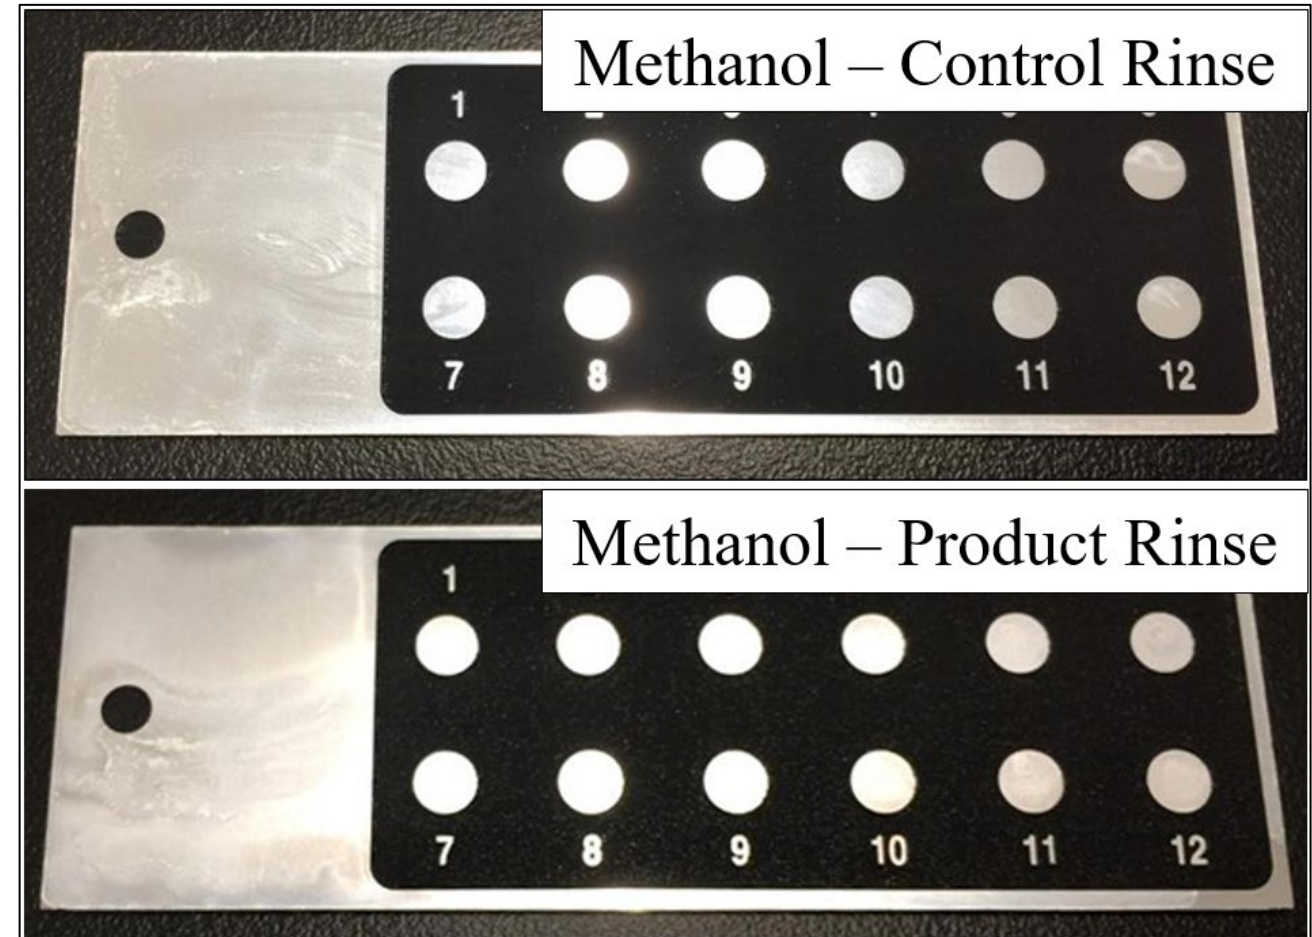
# CS#1 – Surface Organic Detection & Identification Tests

- Test methods:
  - IPC TM-650 Method 2.3.38C – Surface Organic Contaminant Detection Test
  - IPC TM-650 Method 2.3.39C – Surface Organic Contaminant Identification Test (Infrared Analytical Method)
- Two solvents:
  - Methanol
  - AP (Silane A-174) - *Issues*
- Residues on both slides
- More residue on product rinse slide.

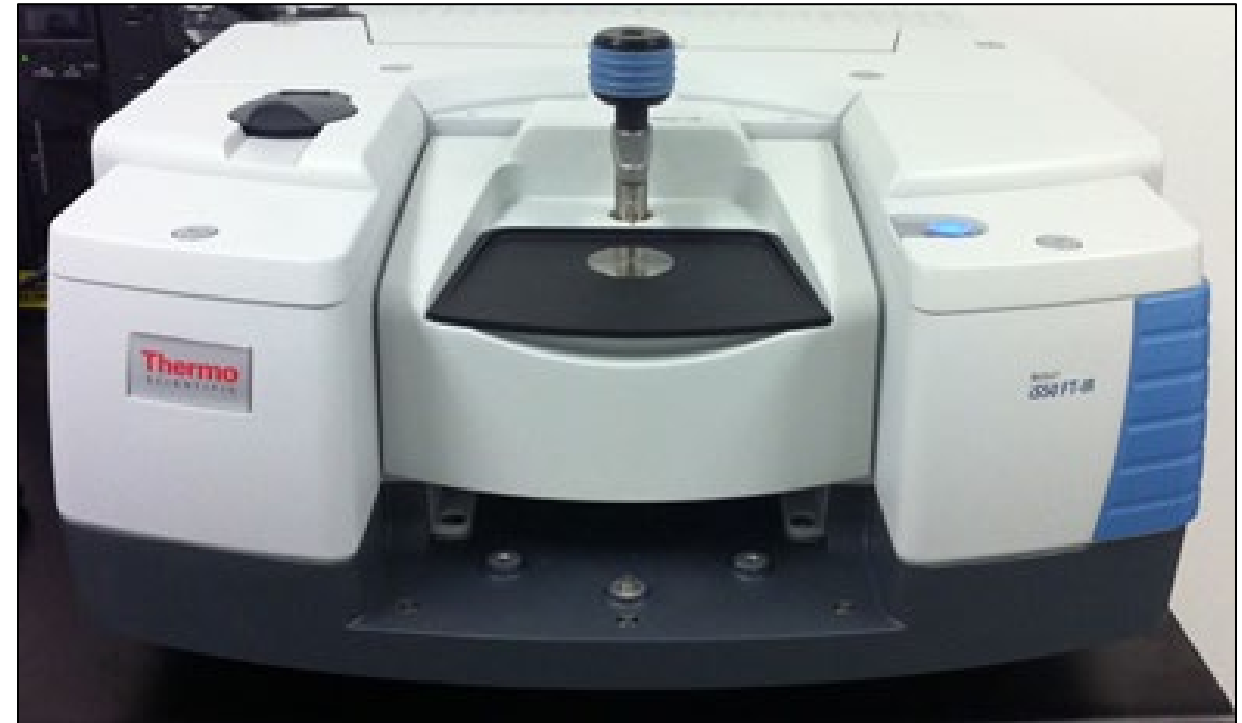
## CS#1 – FTIR Spectroscopy

- Fourier Transform Infrared Spectroscopy
  - Instrumentation:
    - Thermo Nicolet iS50 FTIR Spectrometer
    - Smart iTR ATR Accessory
    - Germanium ATR Crystal
  - Software:
    - OMNIC – Capturing/processing data
    - OMNIC Specta – Multicomponent spectral search with material databases
