# Behind Closed Doors – What You Don’t Know About Your CVD Chamber

Sean Clancy, Ph.D., Robert Askin, HZO, Inc.  
Morrisville, NC, USA  
[sclancy@hzo.com](mailto:sclancy@hzo.com)

### **Case Study #1 – Intermittent and transient failures at FATP, or a series of unfortunate events**

#### **Case Study #2 – “Water is a contaminant, too, especially under vacuum”, or “evaporative cooling can be great, just not usually in your coating chamber”**

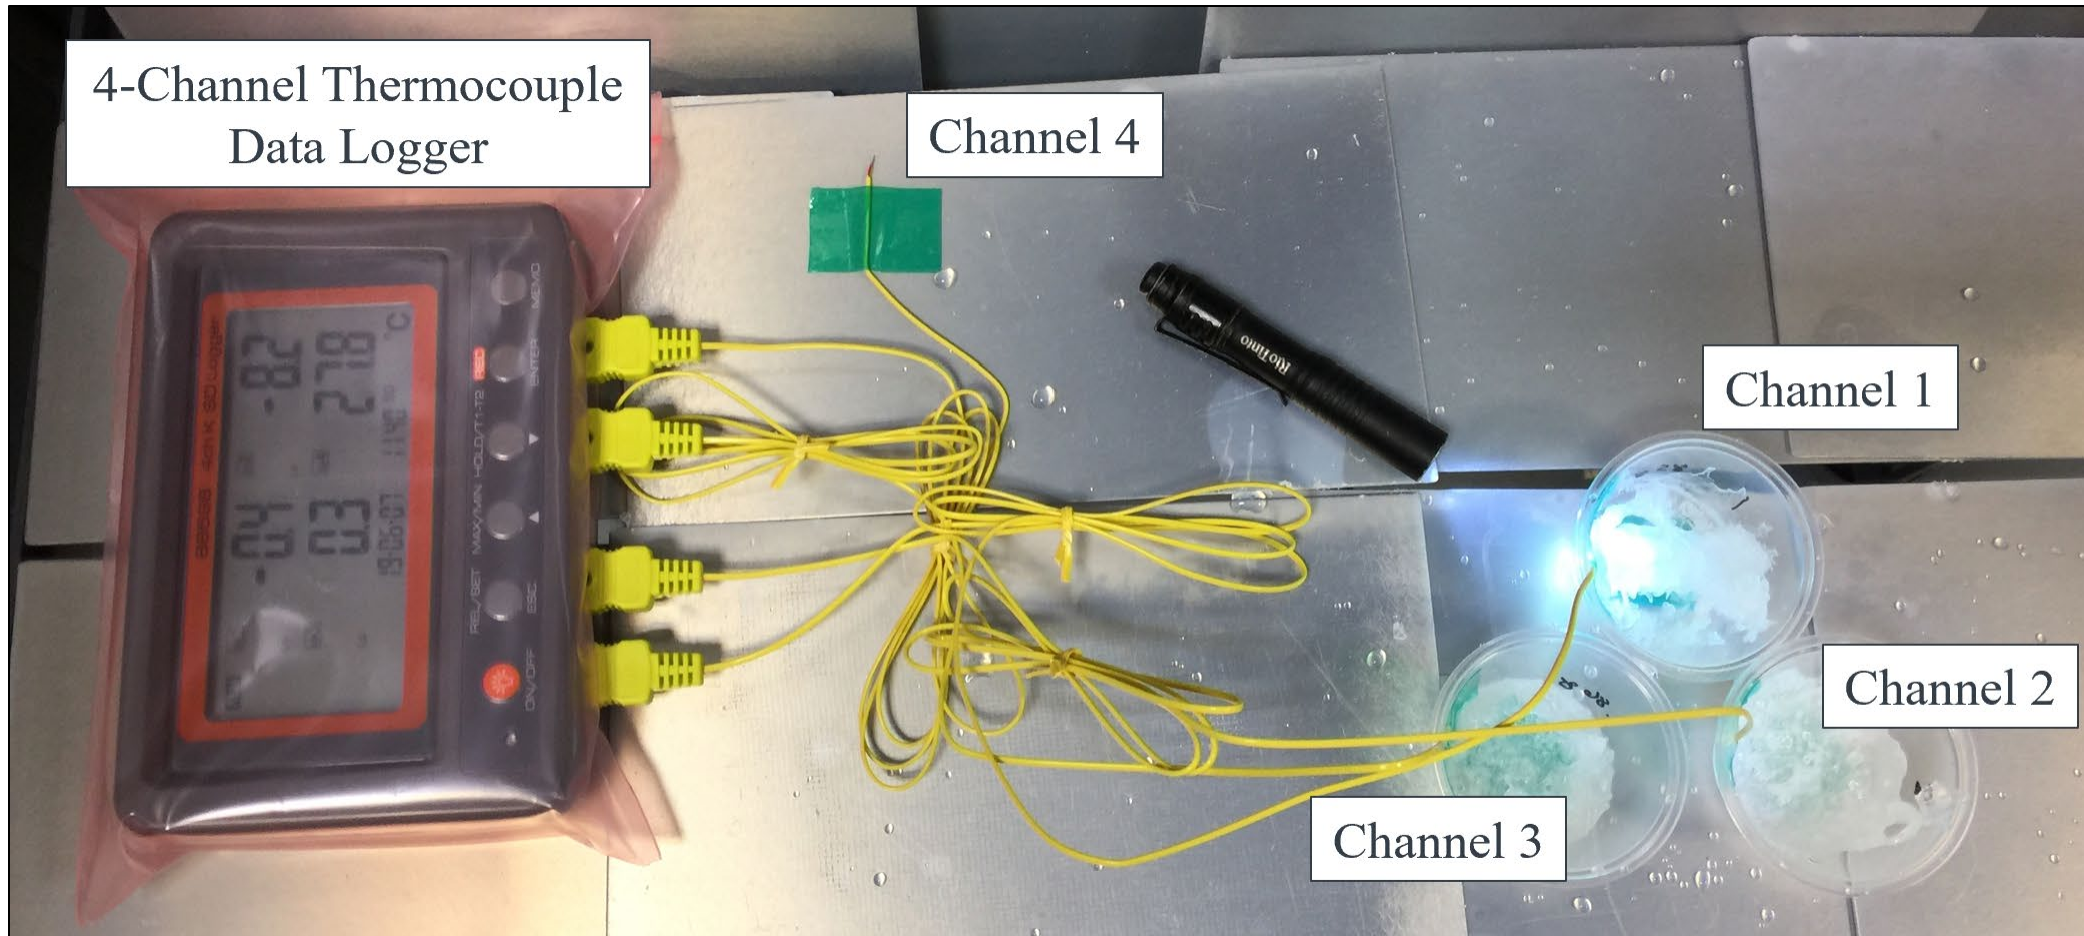
## CS#2 – Experiments to Time Freezing of Water in CVD Chamber

- Thermocouple Channels 1 through 3 in water and Channel 4 as control
- Flashlight as a light source for viewing through chamber's viewport

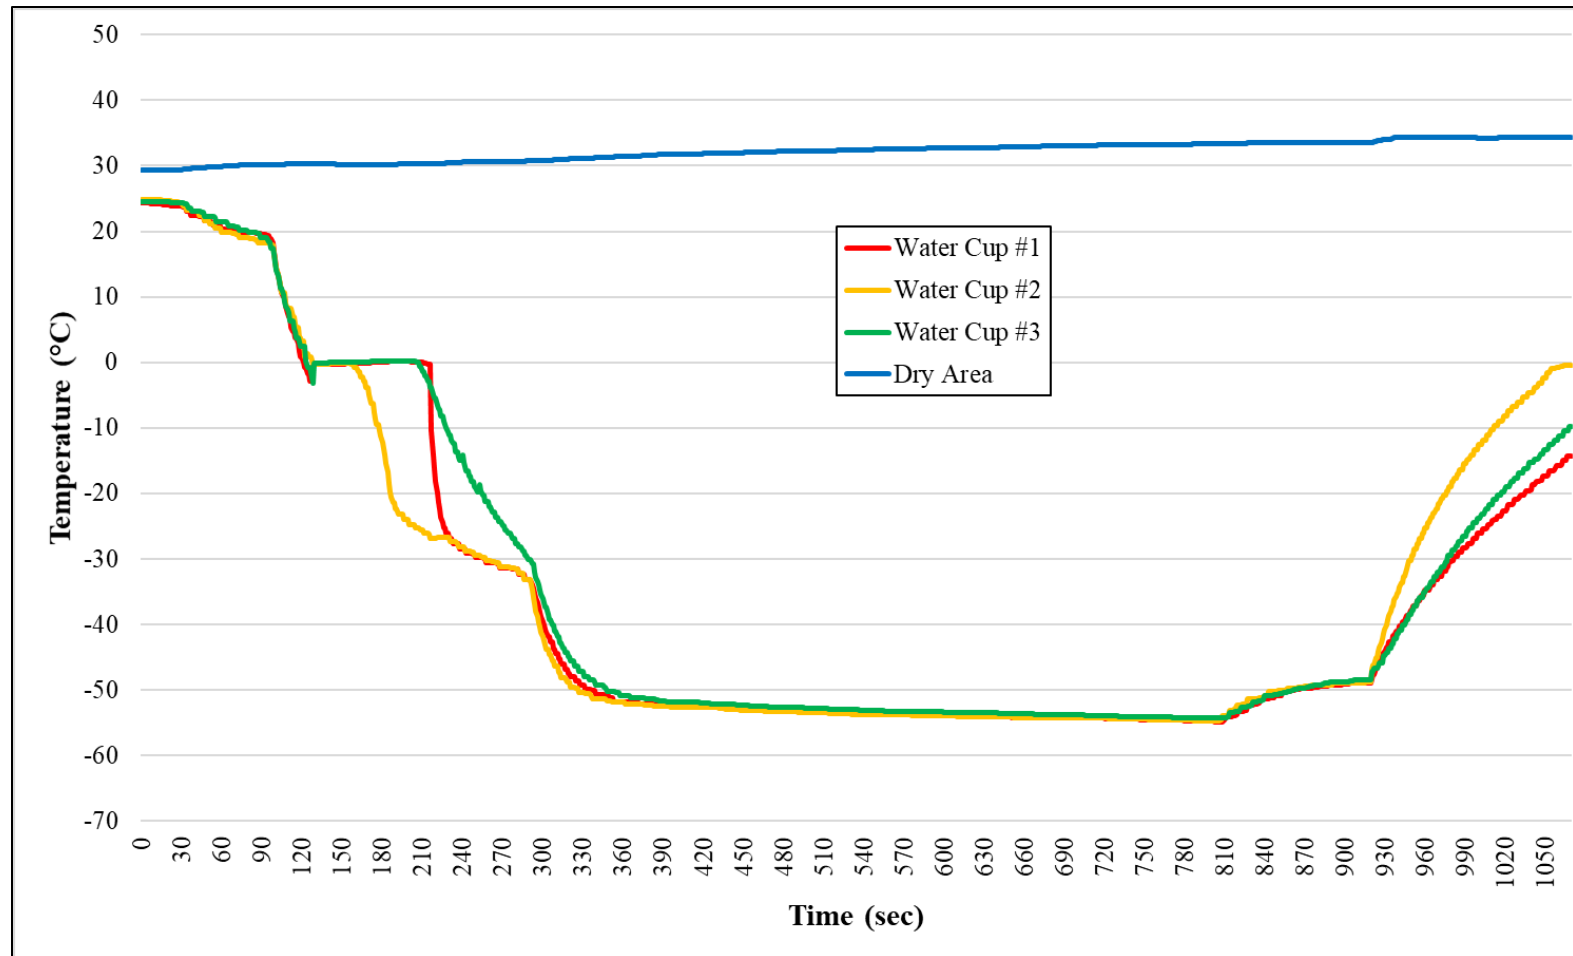
## CS#2 – Experiments to Time Freezing of Water in CVD Chamber

- Water froze within 2 to 3 minutes
- Water temperatures went below -50 °C within 5 to 6 minutes

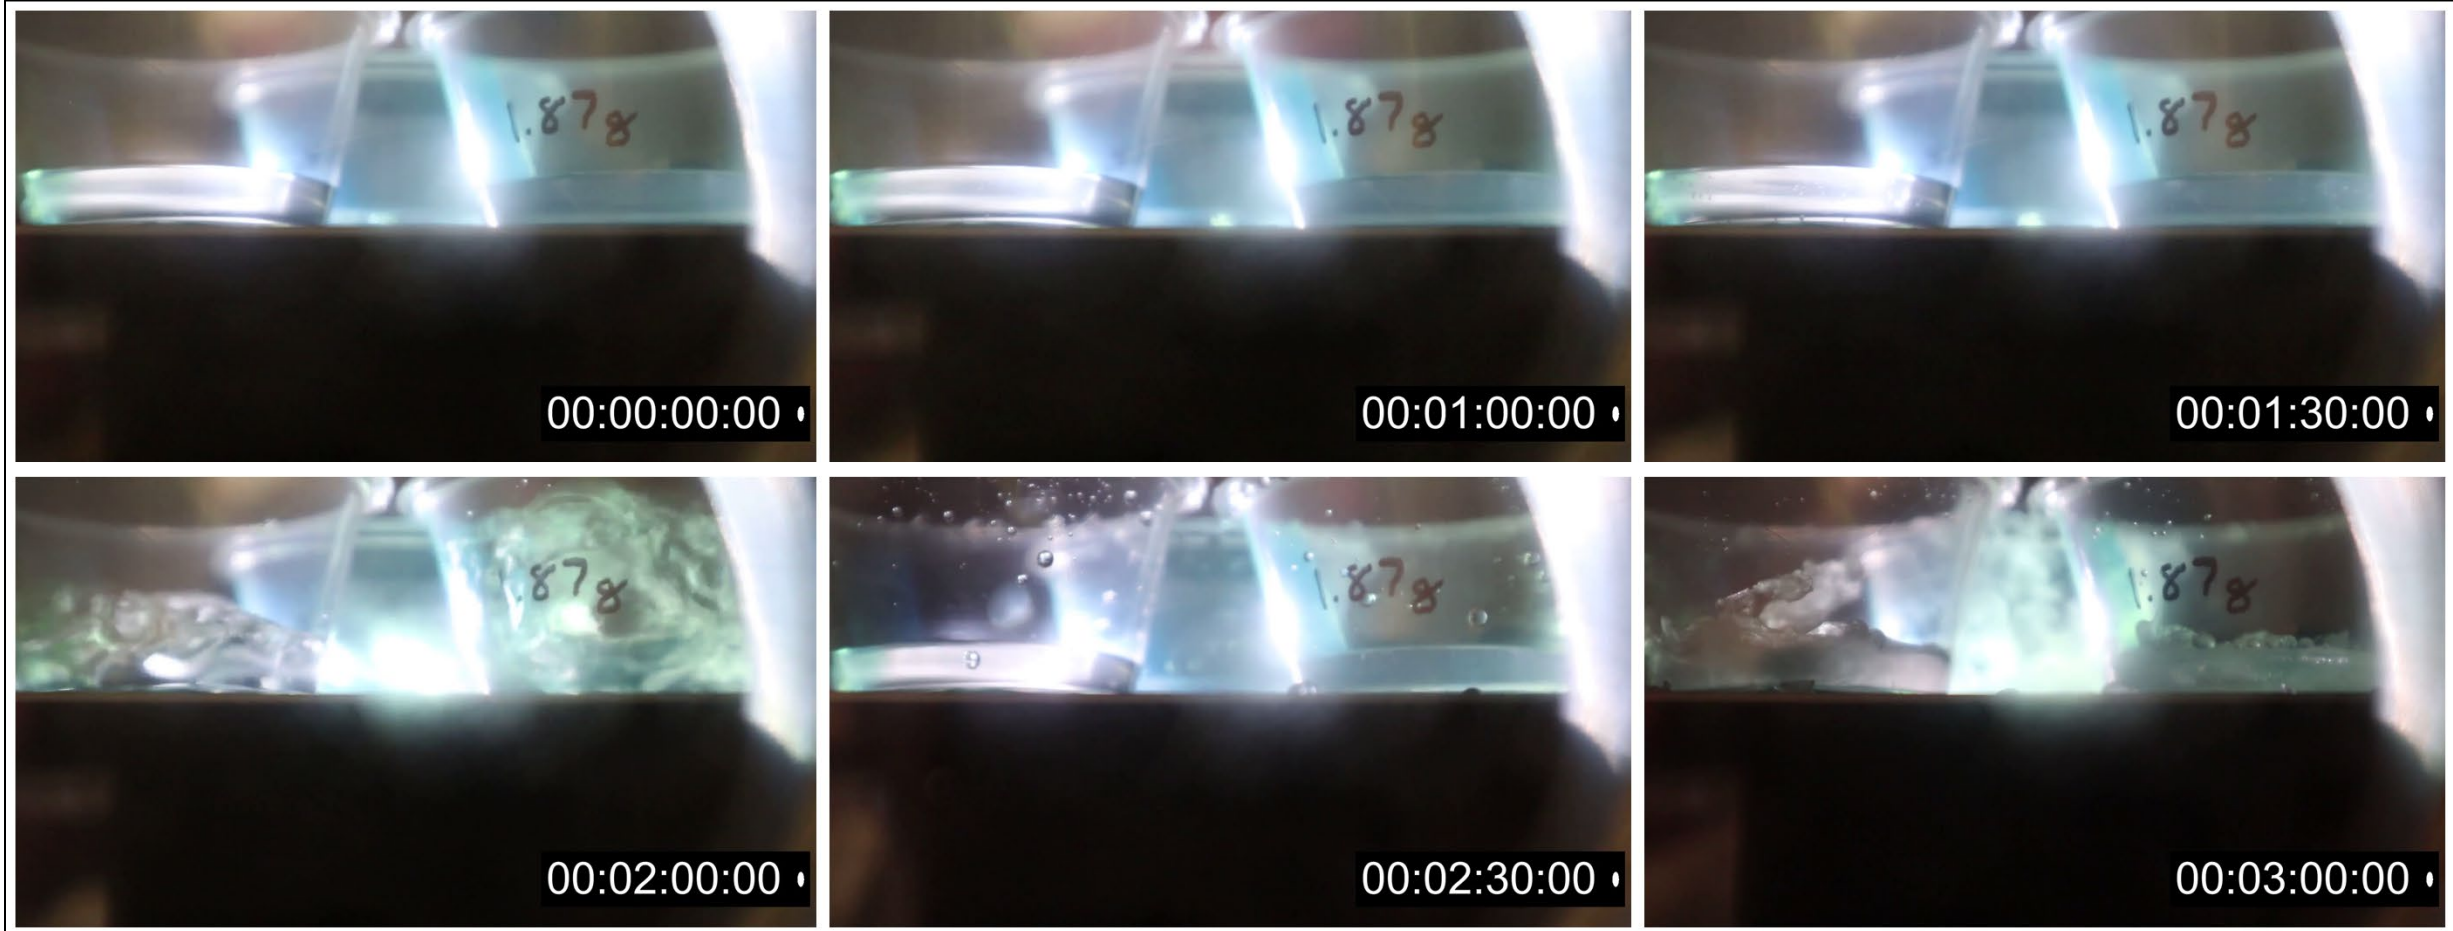
## CS#2 – Experiments to Time Freezing of Water in CVD Chamber

- Snapshots from video captured through the Parylene CVD chamber's viewport
- Water boiled vigorously by the 2-minute mark and appeared frozen by 3 minutes

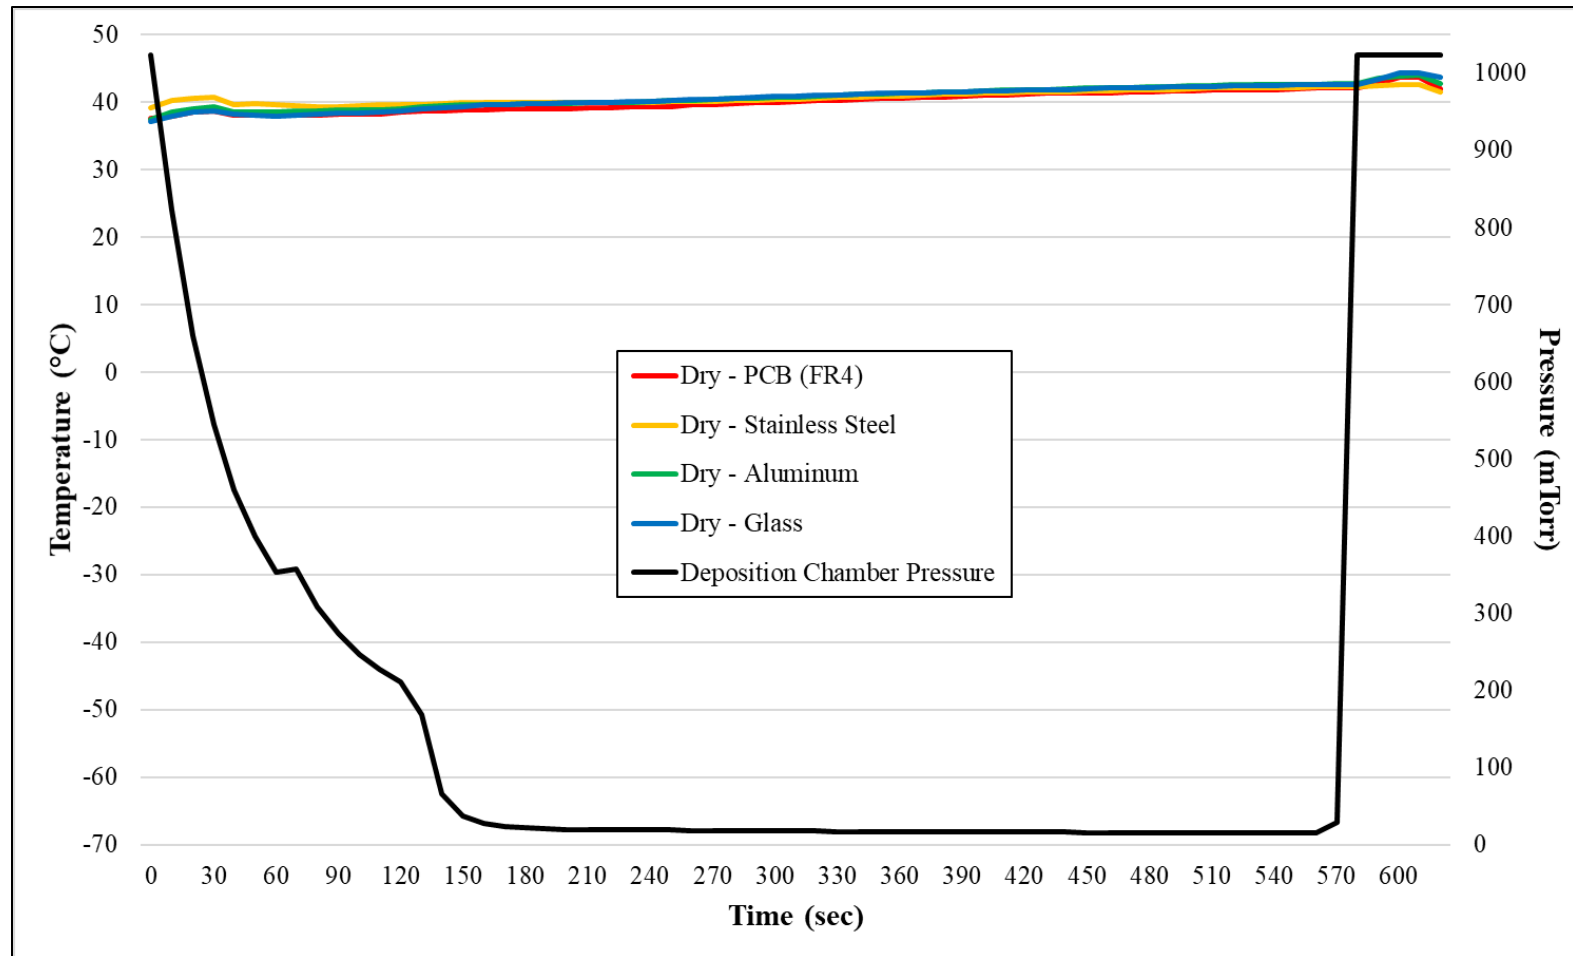
## CS#2 – Temperature vs Time for Dry Substrates

- Four different dry substrate materials were evaluated during pump down
- No appreciable difference was observed

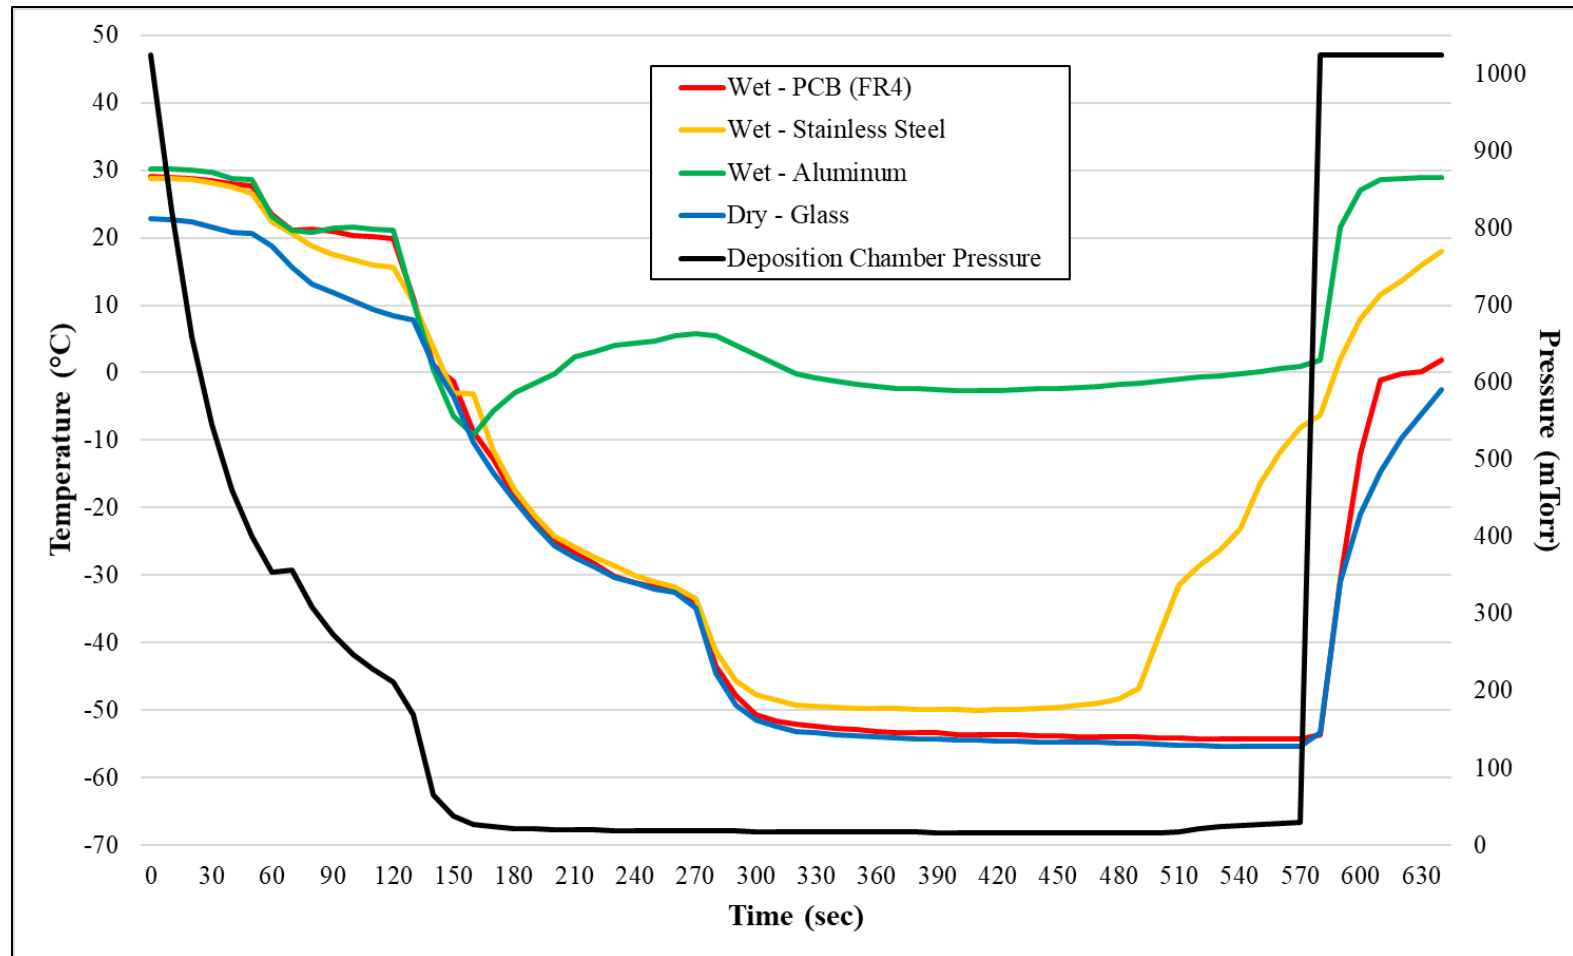
## CS#2 – Temperature vs Time for Wet Substrates

- Water added to different substrate materials and pumped down again
- Aluminum likely had ice form and break off thermocouple, so the lowest temperatures weren't reached

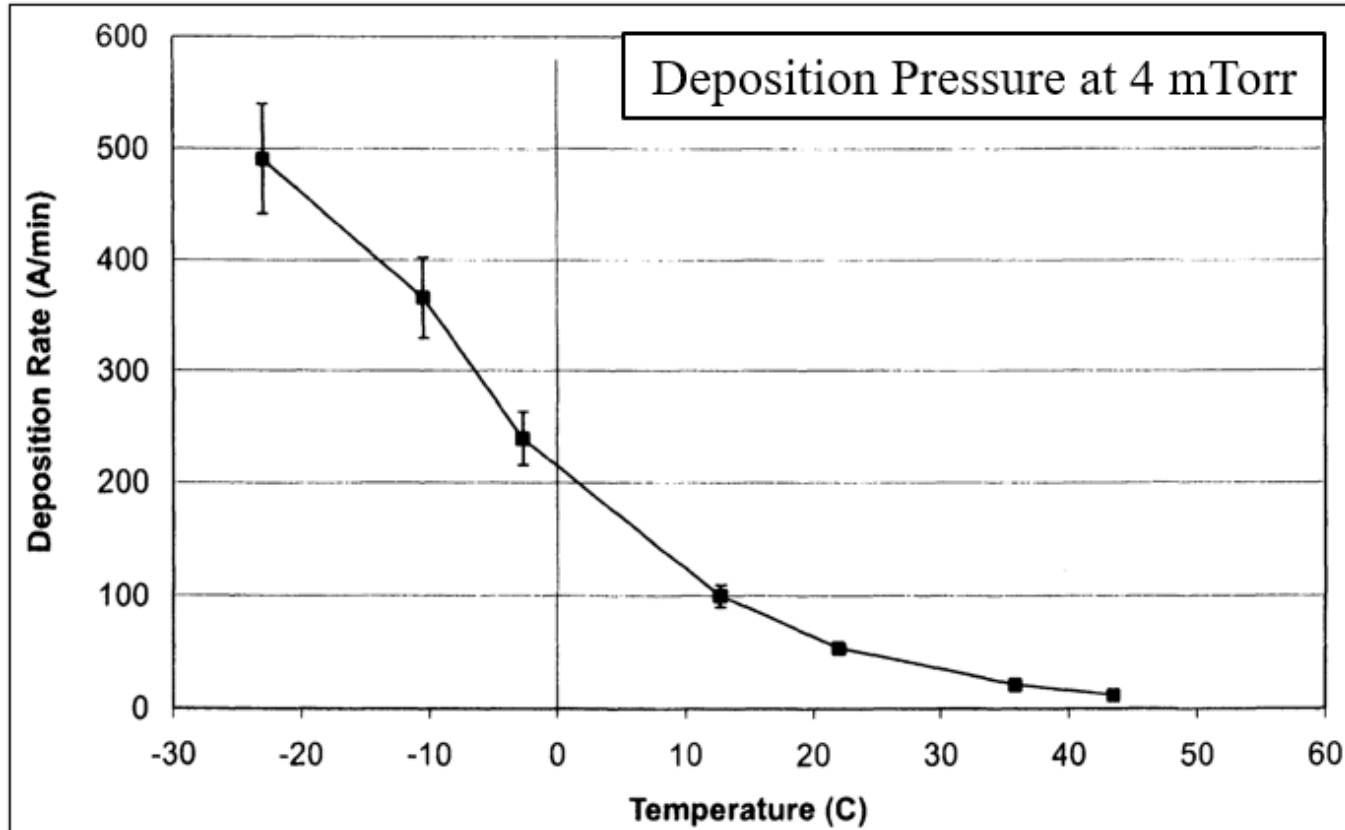
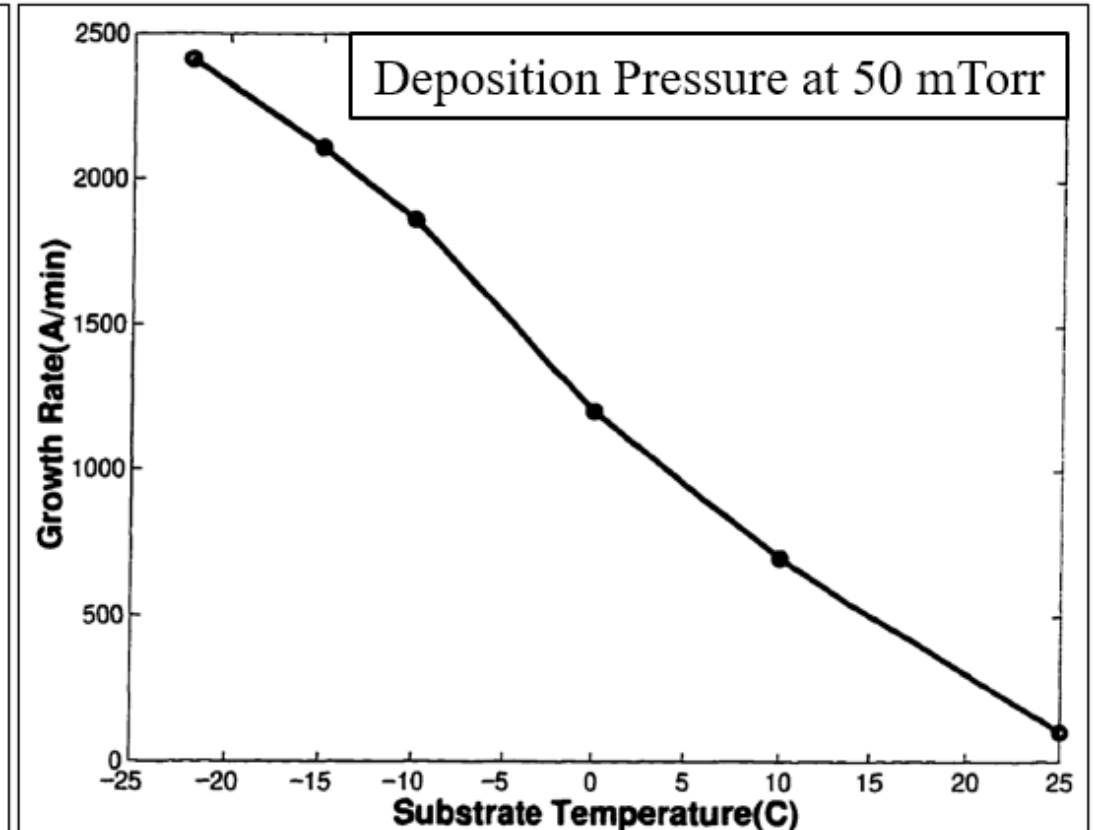
## CS#2 – Deposition Rate vs Substrate Temperature for Parylene N

- Many studies have shown increased deposition rates with lowered substrate temperatures
- Ref.: (Left) J. B. Fortin, T.-M. Lu. "Chemical Vapor Deposition Polymerization: The Growth and Properties of Parylene Thin Films", Springer, New York, **2004**, p. 45. (Right) S. Ganguli, "Step Coverage of Metals and Interlayer Dielectrics in Multilevel Metallization." Rensselaer Polytechnic Institute, Troy, NY, **1997**, p. 130.
